KOEBERG NUCLEAR POWER STATION

LONG TERM REPAIR STRATEGIES FOR THE CONTAINMENT BUILDINGS - EXPERT PANEL REPORT

Document Number : JN465-NSE-ESKB-R-5704
Revision : 0
Status : Issued

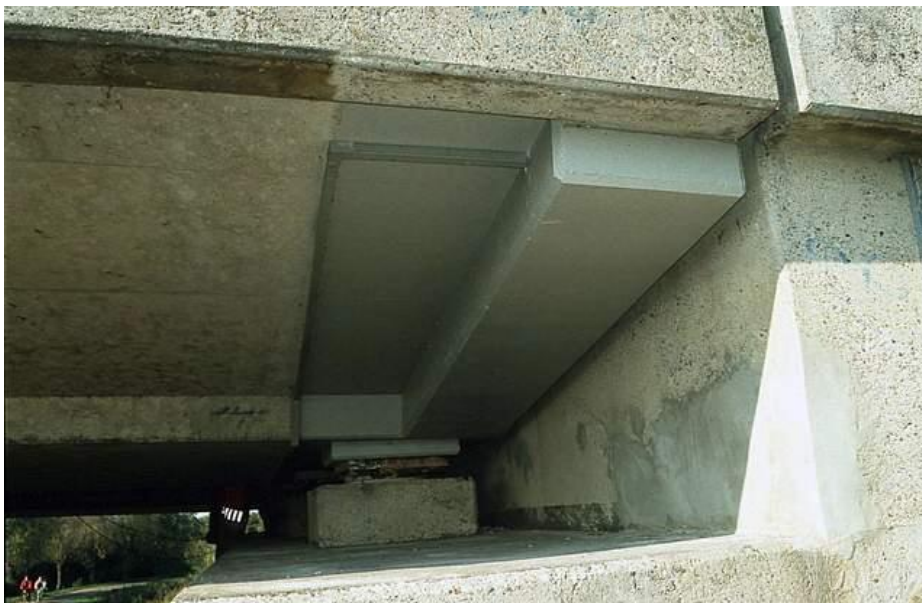
Figure 5: Post-tensioned end beam with conductive coating CP applied

Performance records up to 2011 show that the system works, although at low levels of depolarisation. Silver wire/copper cable connections have been replaced after 8 years.

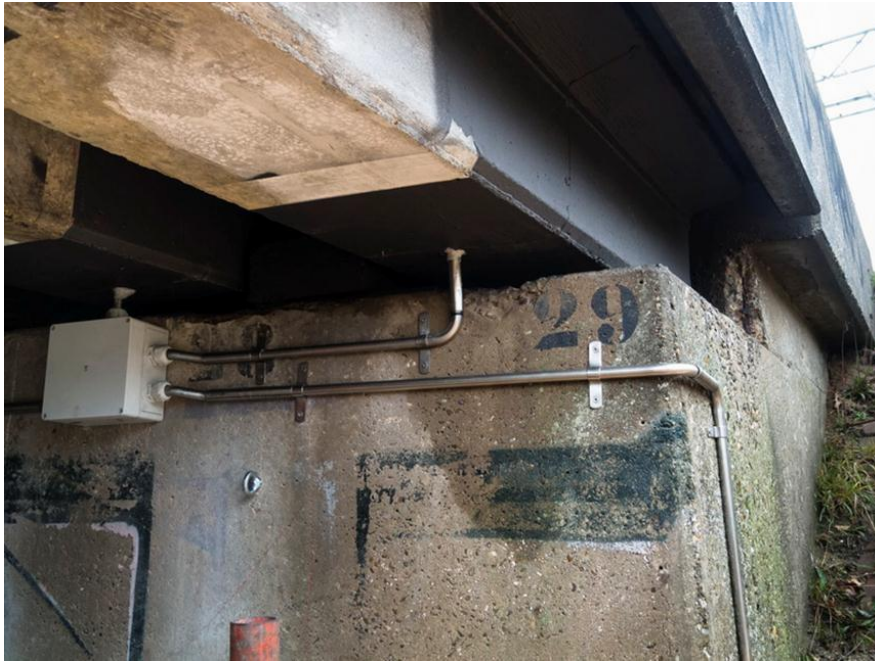
Figure 6: Conductive coating (black) CP applied to ends of post-tensioned bridge deck beams and stainless steel conduits to power supply box

The final situation is shown in Figure 6.

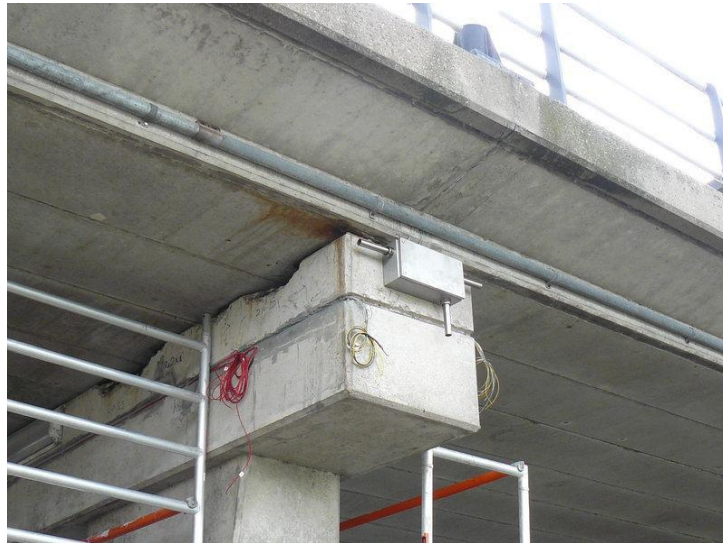
Figure 7: Reinforced cross beam with slots cut

Measurements in 2010 indicated an overall satisfactory level of depolarisation; however, significant variation occurred between the 18 reference electrodes; and one data logger unit malfunctioned. Figure 7 shows a beam being provided with slots and cabling.

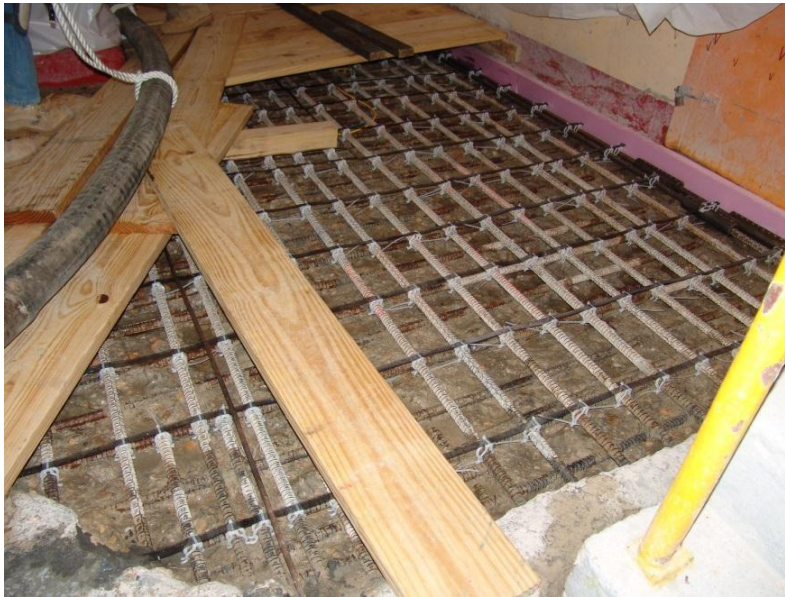
Figure 8: Titanium Ribbon Mesh Anode installed in Concrete Repair using Plastic Rebar Clips (Source: Corpro Companies, Inc.)

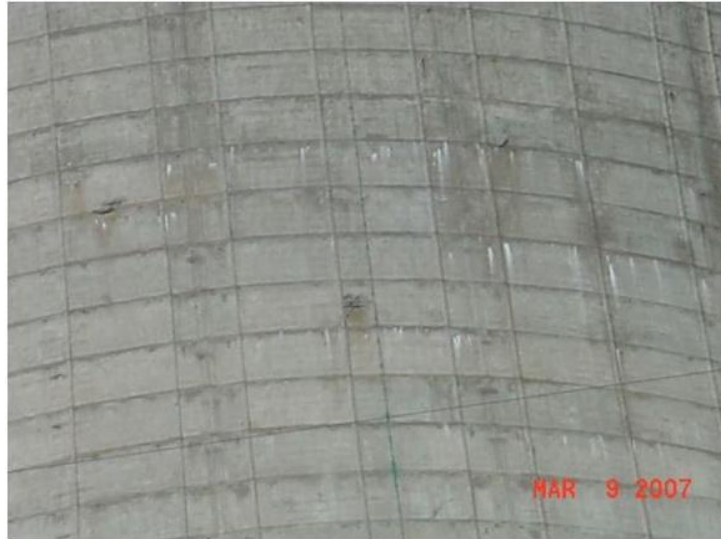
Figure 9: Slotted Titanium Ribbon Mesh Anode System and Probe Titanium Anode System ([REDACTED])

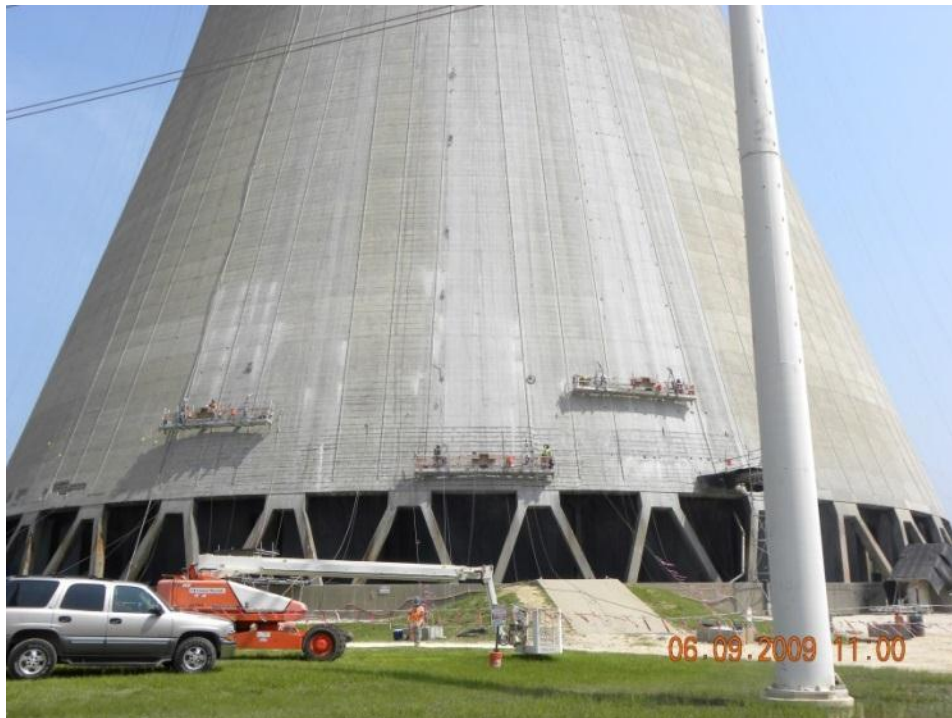
Figure 10: Installation of an Impressed Current System on a Hyperbolic Cooling Tower ([REDACTED])

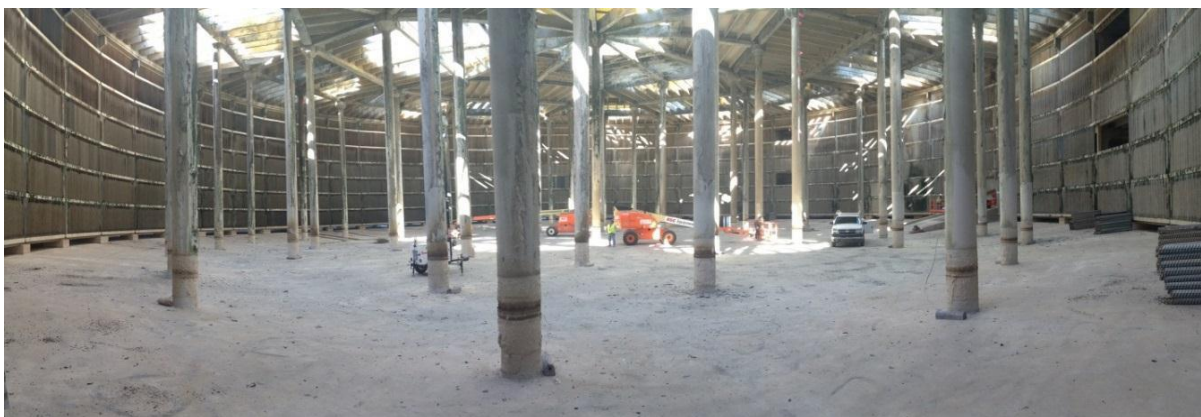
Figure 5-1.
Galvanic Anodes at Base of Cooling Tower Columns

- A. Submerged Portion of Reinforced Concrete Cooling Tower Columns in the Power Block. There are 9 forced-draft cooling towers site-wide (3 for each unit). Each tower consists of 49 internal support columns. The base of the reinforced concrete columns are continuously exposed to aggressive chemicals in the cooling water (treated sewage water). The system consists of one 32-lb bare high potential magnesium anode that is attached to the reinforced steel at the base of each column using the anode lead wire (see Figure 5-1 below). APS visually inspect the galvanic anodes during refueling outages (every 18 months) and replace any anode that has lost significant mass. Typically 1/3 of the anodes are replaced every outage. APS do not have any test sites to monitor system performance. All inspections are visual.

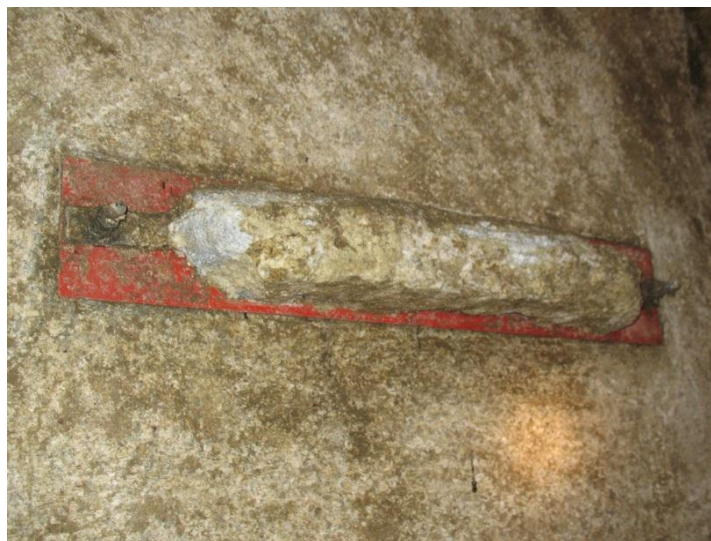
Figure 5-2. Galvanic Anode in Circwater Cooling Tunnel

- A. Reinforcing Steel of Circulating Water Conduits. A galvanic aluminum anode CP system was installed to protect the reinforcing steel in the Diablo Canyon circulating water conduits. Each of the 2 units has two 12-ft x 12-ft reinforced concrete tunnels which provide seawater for the main condenser and auxiliary cooling. The tunnels vary in length from 1,350 to 1,610 ft. A galvanic anode system consisting of 140-lb aluminum anodes (Galvalum™ III alloy) was designed and installed in the mid-1990s to control corrosion of the reinforcing steel in the tunnel walls.¹ The anode core is bolted to the reinforcing steel. PG&E visually inspect the galvanic anodes during refueling outages and replace any anode that has lost significant mass. According to PG&E the anodes at the ends of the tunnels are consuming faster because of the increased steel density. The anodes that are located remote from the ends of the tunnels (where the steel density is less) last approximately 10-20 years. Figure 5-2 provides a view of a partially consumed aluminum anode. A monitoring system was installed, however the anodes are shorted to the reinforcing steel and therefore anode current measurements and polarization decay testing cannot be performed.

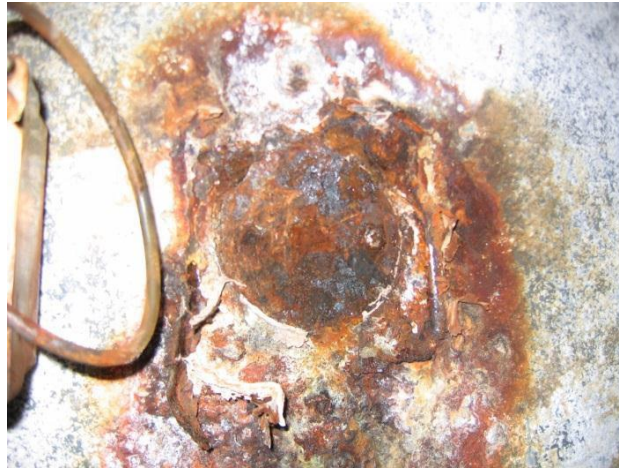
Figure 5-3.
Thermally Sprayed Zinc Anode Connection Failure in Seawater Intake Structure

- A. anode consumption. Figure 5-3 provides a view of an anode connection failure due to water leakage and oxidation inside a junction box.

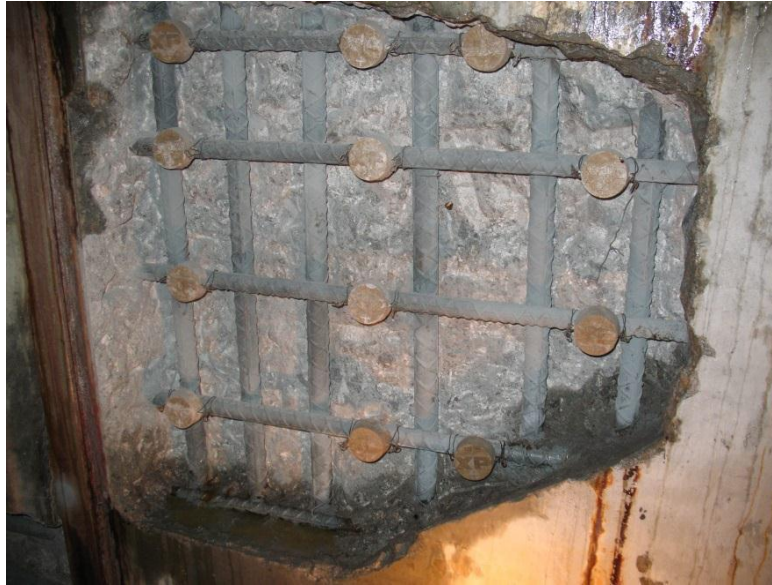
Figure 5-4.
Point Type Zinc Anodes installed in Concrete Repair of Seawater Intake Structure

- C. Concrete Repairs in Seawater Intake Structure. Point type zinc galvanic anodes have been installed in the concrete repair material of the atmospherically exposed sections of the seawater intake structures. The “hockey puck” anodes are installed at approximately 12” on center to form a grid (see Figure 5-4). Unfortunately a corrosion monitoring system was not installed during construction and no updates on system performance are available.

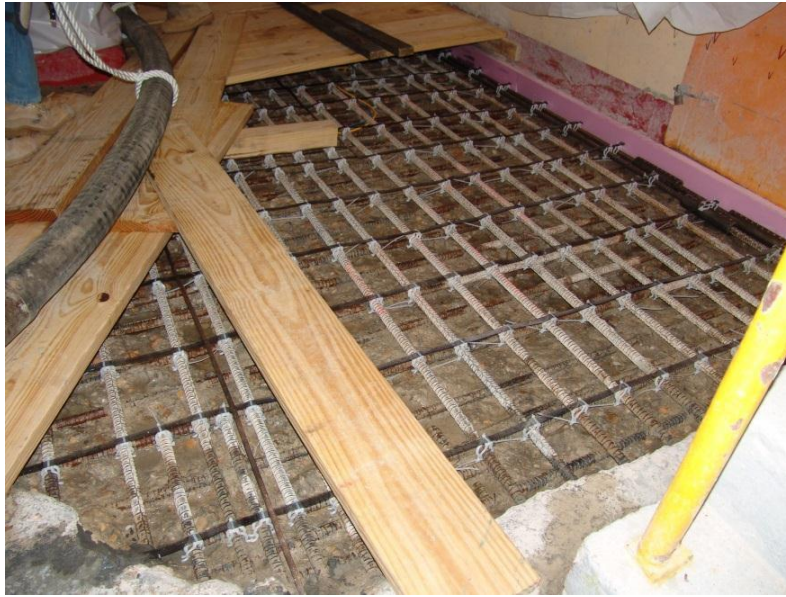
Figure 5-5.
Titanium Ribbon Mesh Anode installed in Concrete Repair using Plastic Rebar Clips

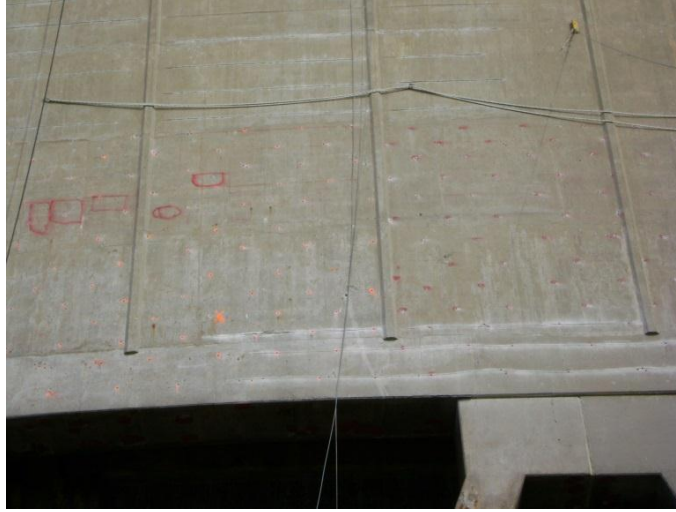
Figure 5-6.
Slotted Titanium Ribbon Mesh Anode System and Probe Titanium Anode System

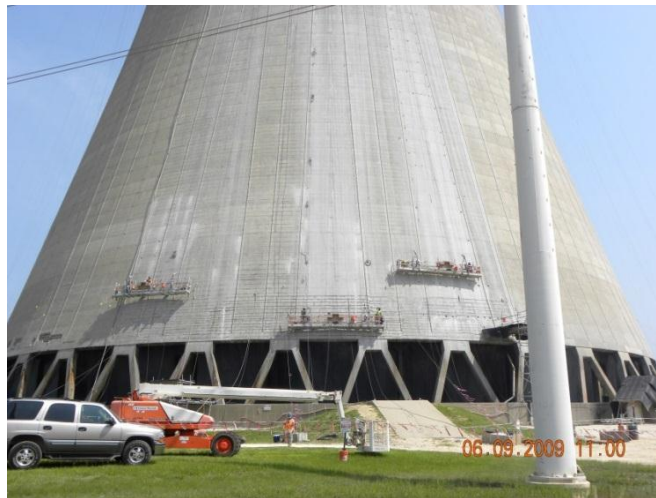
Figure 5-7.
Installation of an Impressed Current System on a Hyperbolic Cooling Tower

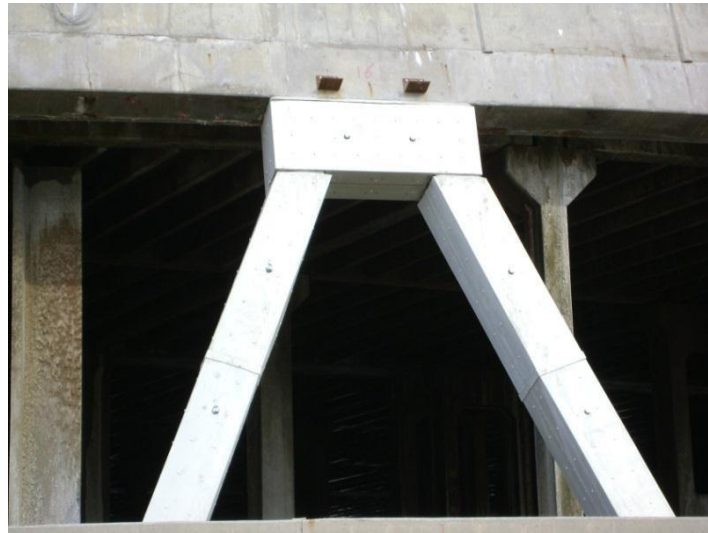
Figure 5-8.
Lif jacket System for Lintel Beam and Support Columns

- A. Of the 160 support columns that are protected by the LifeJacket system, only 10% are monitored. Of the 16 monitored columns, approximately 75% have more than 100 mV of polarization development from the native potential values.

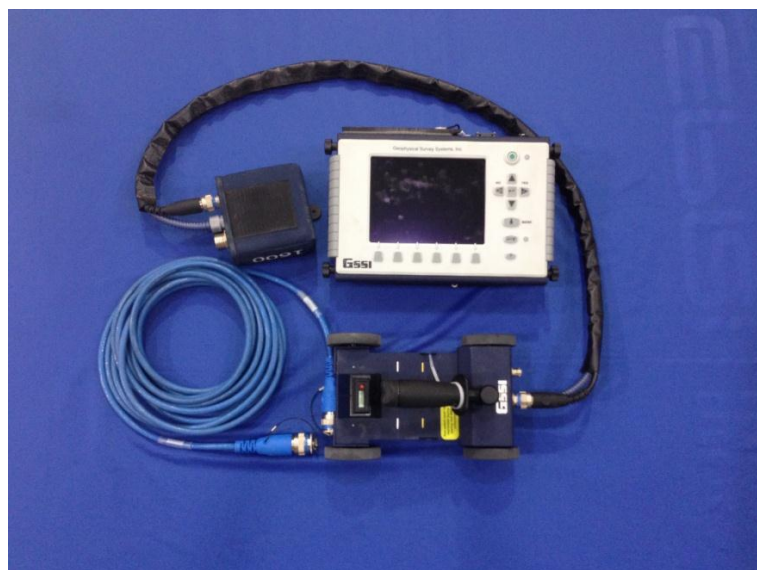
Figure 11: Commercially available GPR unit with a 1600 MHz antenna.

The method is based on the propagation and reflection of electromagnetic waves through a media. The equipment consists of an operating unit and an antenna that serves as a transmitter and a receiver. The antennas operate at different frequencies depending on the material in question. The most commonly used antennas for concrete investigations range between 900 MHz and 2600 MHz. Figure 11 presents a 1600 MHz commercially available system typically used for evaluation of concrete embedments.

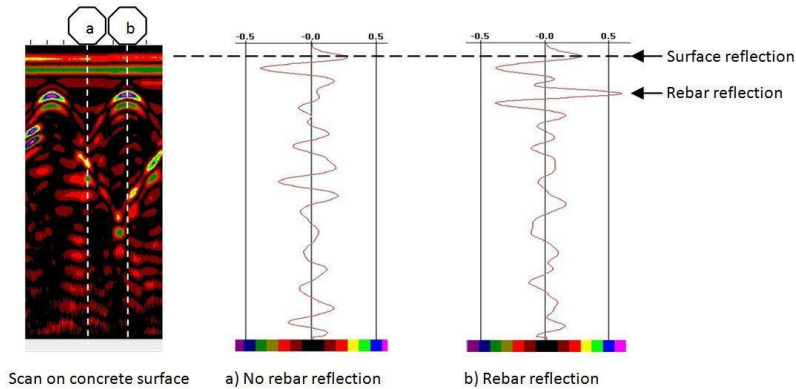
Figure 12: Example of a GPR scan. Scan location a) was performed at a location where no near surface rebar was present. Location b) is at the centre of a piece of rebar. Note the difference in the amplitude of signal for the same depth of the scans with and without the rebar.

The operator needs to be cognizant of the surface reflection (first positive reflection on the wiggle plot) and the reflections of the reinforcing steel (Figure 12). The reflection to the steel reinforcement, in this case will be the secondary and strongest positive reflection in the wiggle plot at the rebar location.

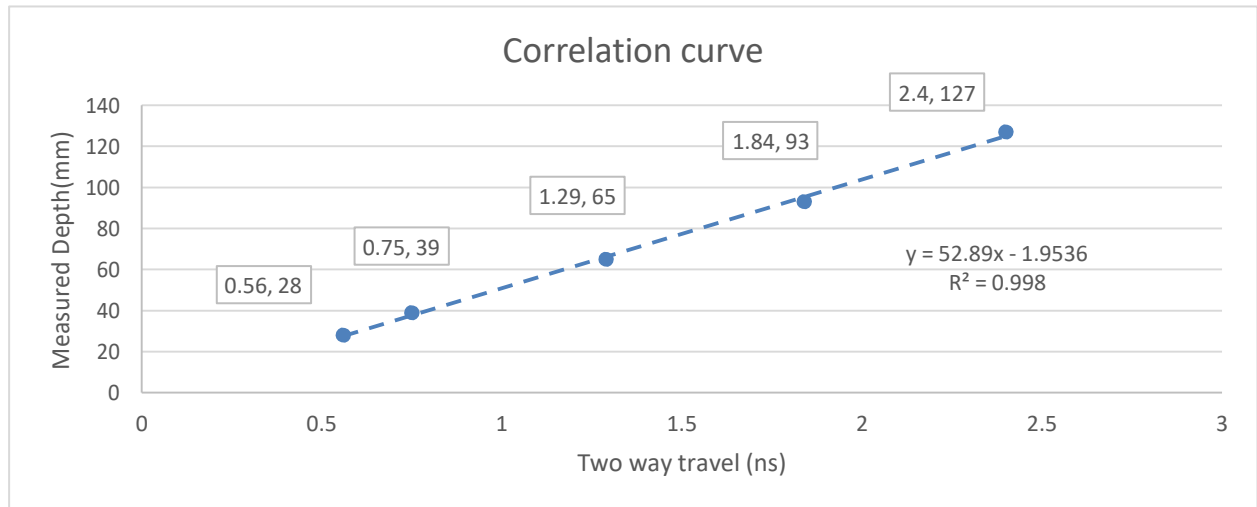
Figure 14: Plotted values of measured cover depth and two way travel times.

Figure 14 presents the correlation curve (linear fit) of the five points measured. The points were plotted in Microsoft Excel® and a linear fit line was included in the plot. The equation correlating the cover depth and the two way travel time was also obtained from Excel®.
